# Investigating Artificial Levees

## CASE STUDY

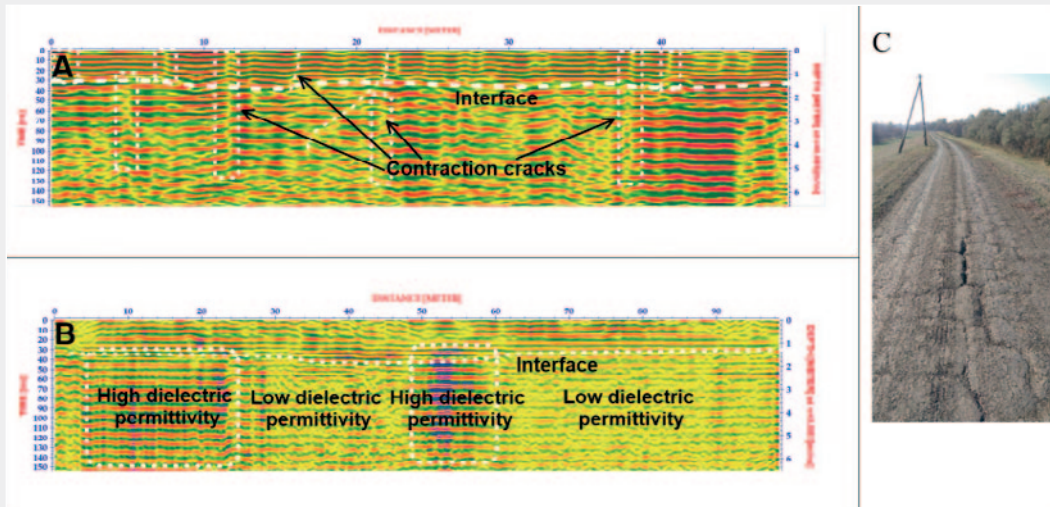
*Representative profiles for the identified GPR anomaly types: A) contraction cracks, B) remarkable changes in dielectric permittivity, and C) Photo showing the contraction cracks on the levee crown.*
