INVESTIGATION OF ABNORMAL SEEPAGES IN AN EARTH DAM USING RESISTIVITY TOMOGRAPHY

Chih-Ping Lin [1], Yin-Chun Hung [2], Zen-Hung Yu [3], and Po-Lin Wu [4]

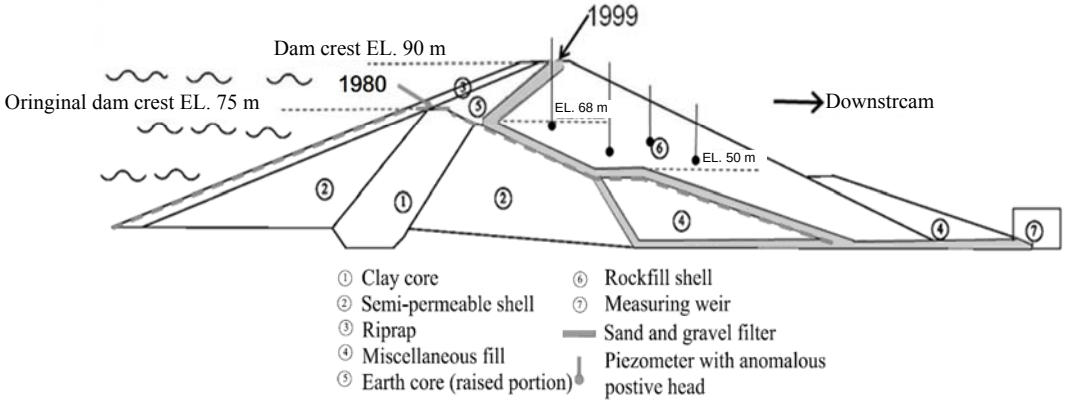
The major cross section of the dam is shown in Fig. 3. The original dam was constructed up to EL. 75 m as a zoned earth dam with inclined core and toe drain. To raise the dam while accommodating the original dam configuration, the added core was further inclined toward the downstream and a vertical drain of unusual shape was added. Not long after the water level was raised above the old crest elevation, a few abnormal seepage spots were identified on the surface of the downstream slope, as shown in Fig. 4. The water level was decided to remain below EL. 83 m before the abnormal seepage problem is clarified.

Fig. 3 Major cross-section of the Hsin-Shan zoned earth dam

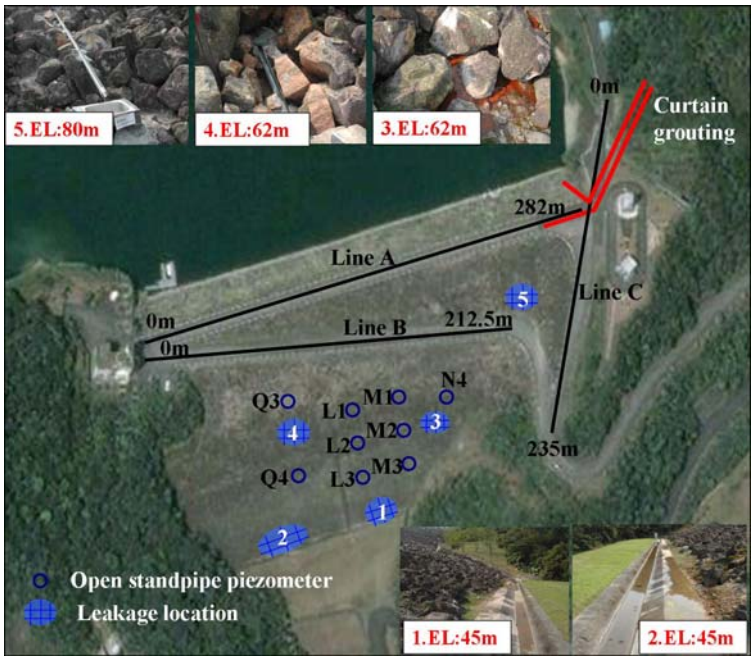
The earth dam is covered by 3 m of ripraps except for the crest and a downstream passageway, making extensive self potential survey and transverse ERT survey lines on the shell difficult. As a first attempt of geophysical investigation on the Hsin-Shan earth dam, three survey lines were deployed as shown in Fig. 4. To see into the earth dam, Line A extends the whole range of the crest while Line B covers the straight part of the downstream passageway. Line C is located at the left abutment and passes through the curtain grout. Line B was further used for long term monitoring to investigate the relationship between resistivity variation and other environmental factors.

Fig. 4 Layout of ERT survey lines and photographs showing abnormal seepages at the downstream face

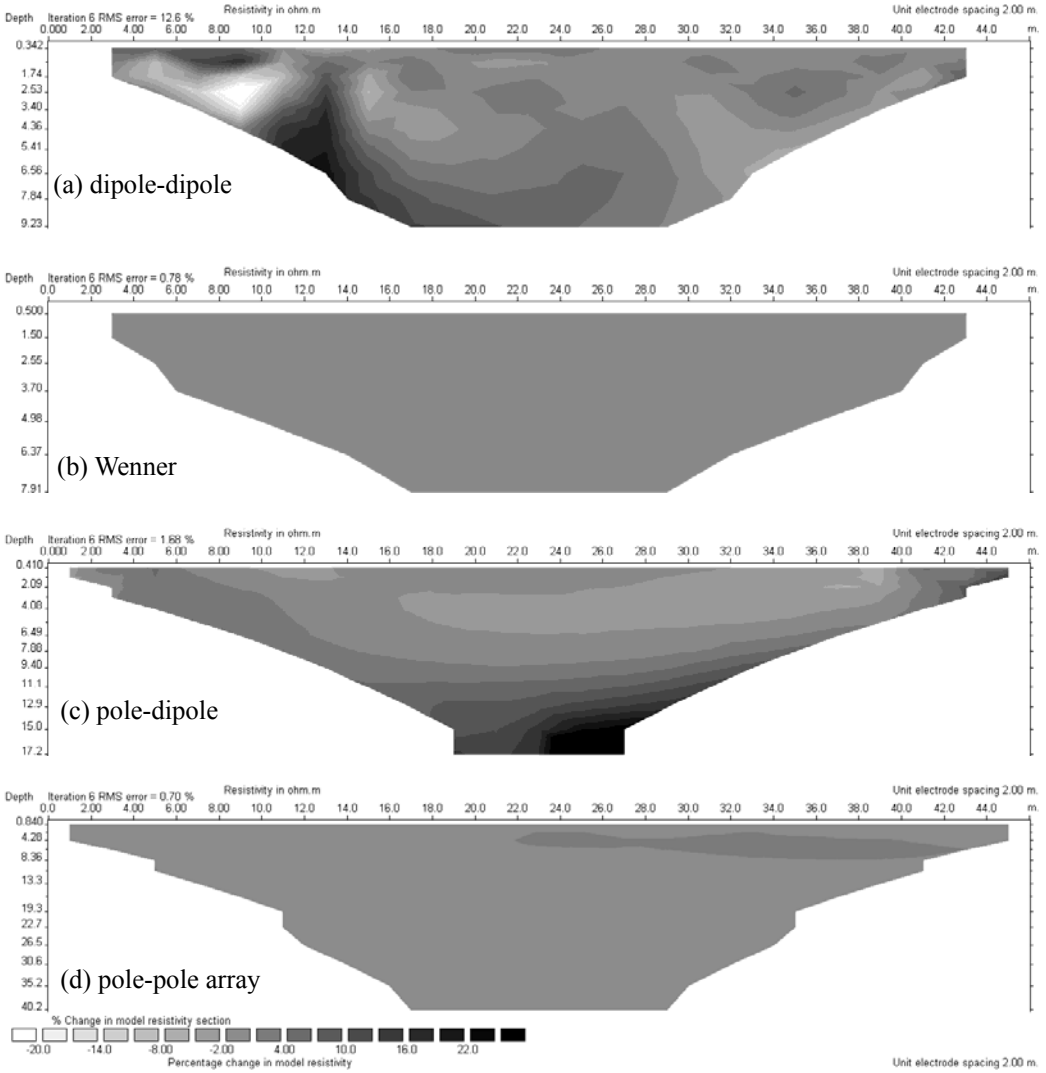
Fig. 5 Percentage change of inverted resistivity between two repeated measurements for (a) dipole-dipole; (b) Wenner; (c) pole-dipole; and (d) pole-pole array, respectively

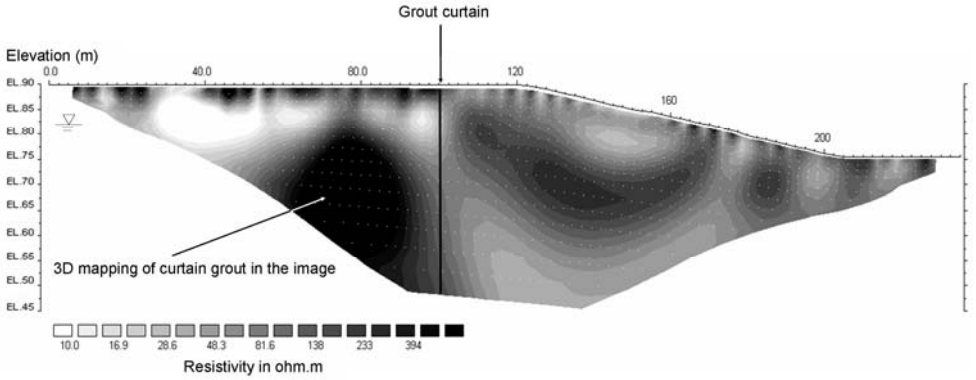
Special attention was paid to the left abutment in earlier investigations. Thus two curtain grouts had successively installed to reduce the leakage. The result of ERT at line C passing through the curtain grout is first examined to evaluate the effectiveness of grouting at the left abutment. The inverted resistivity cross-section is shown in Fig. 6. An apparent low resistivity zone can be seen from Distance 20 m to 70 m near EL. 80 m. This is attributed to the 3D effect of a nearby water intake steel pipe running through. Line C intersects with the curtain grouts at Distance 100 m. But the survey line is not perpendicular to the curtain grouts as shown in Fig. 4. A vertical band of high resistivity exists from Distance 60 m to 100 m. This is believed to be the 3D effect mapping of the solidified ground by the grouting. No apparent lateral flaw in terms of low resistivity zone is found in the grouting area and at the downstream side of the curtain grout.

Fig. 6 Inverted resistivity cross-section for Line C at the left abutment

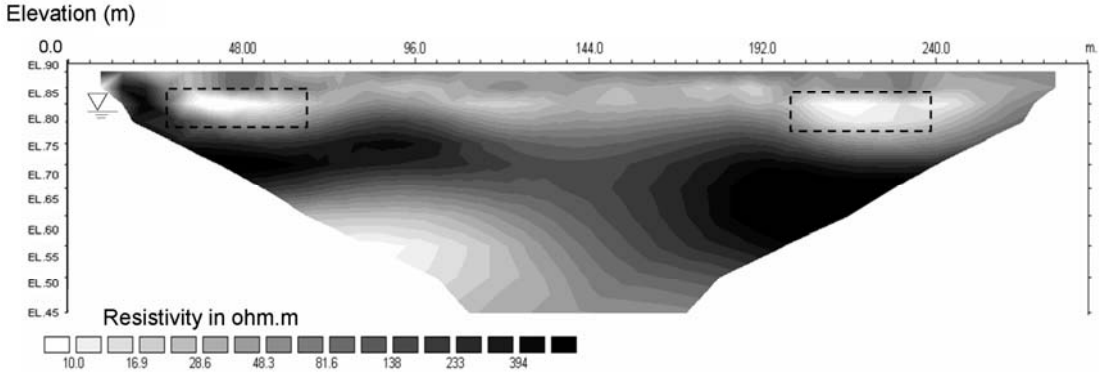
The inverted resistivity cross-section from Wenner array along the dam crest is shown in Fig. 7. A relative low resistivity layer is located near and above the reservoir level. In particular, two low resistivity zones are identified. One is located at Distance 30 ~ 60 m and EL. 79 ~ 84 m, which is mostly above the reservoir level. The other is located at Distance 200 ~ 250 m and EL. 76 ~ 84 m. Since most area of this low resistivity layer is located above the reservoir level, it may be attributed to wetted area or perched groundwater due to rainfall infiltration. Another deeper zone of low resistivity can be found at Distance 70 ~ 100 m below EL. 61 m. It should be noted that this low resistivity zone is mostly below the drainage layer. It is also below the elevation of the abnormal seepage.

Fig. 7 Inverted resistivity cross-section for Line A along the dam crest

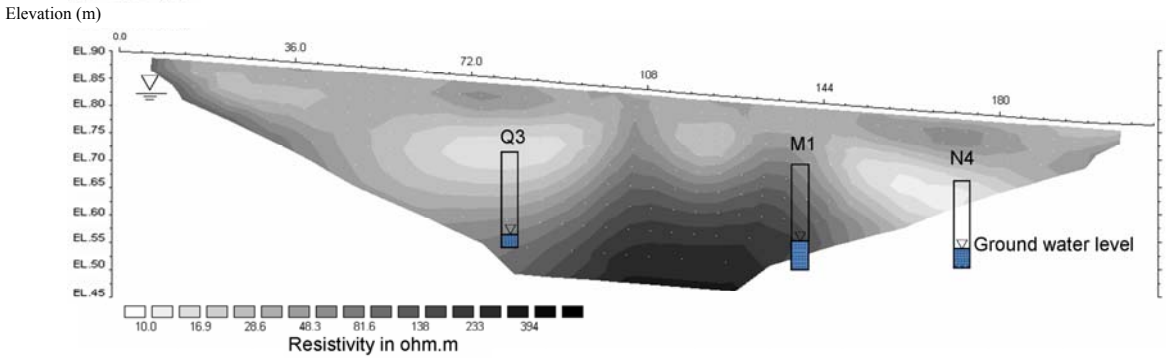
Figure 8 presents the inverted resistivity cross-section of Line B on the downstream shell. The result shows lower resistivity at elevation above EL. 60 m. Two low resistivity anomalies are located at Distance 68 ~ 90 m and 150 ~ 180 m, respectively at elevation EL. 68 ~ 75 m and 60 ~ 73 m. Three ground-water observation wells are located near the downstream side of Line B, as shown in Fig. 4. The well water levels are projected on the resistivity image in Fig. 8. The two low resistivity zones seem to be well above the seepage phreatic line, suggesting two perched wet areas in the downstream shell.

Fig. 8 Inverted resistivity cross-section for Line B along the passageway on the downstream shell

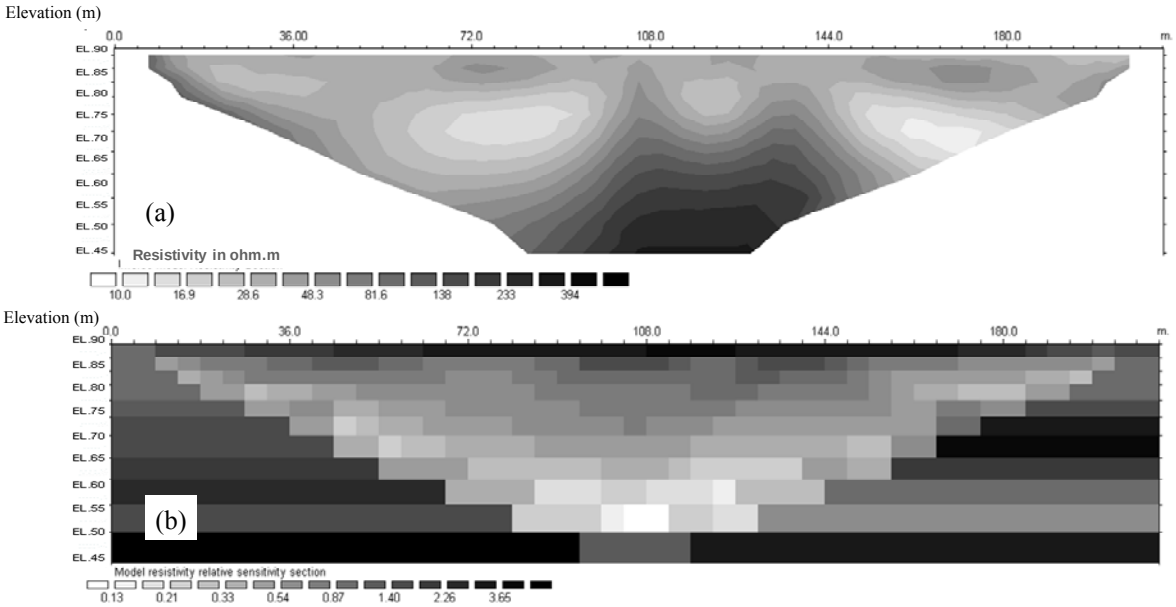
Fig. 9 (a) The resistivity image (before topography correction) for Line B; (b) the corresponding model blocks sensitivity

simulating the field measurement. The inverted resistivity cross-section using the synthetic data is shown in Fig. 10(b). Great similarity can be found when it is compared with the result from actual field measurement (Fig. 9(a)). The uncertainty of the ERT inversion can be qualitatively comprehended by comparing the inverted cross-section (Fig. 10(b)) to the synthetic ground truth (Fig. 10(a)). Although the contour of the inverted resistivity model reveals apparent non-linear features, this is most likely artifacts resulted from poorly-resolved inversion. The results of Line A and Line B basically indicate two low resistivity zones in a more or less layered system. With this level of comprehension, over interpretation of ERT results can be avoided.

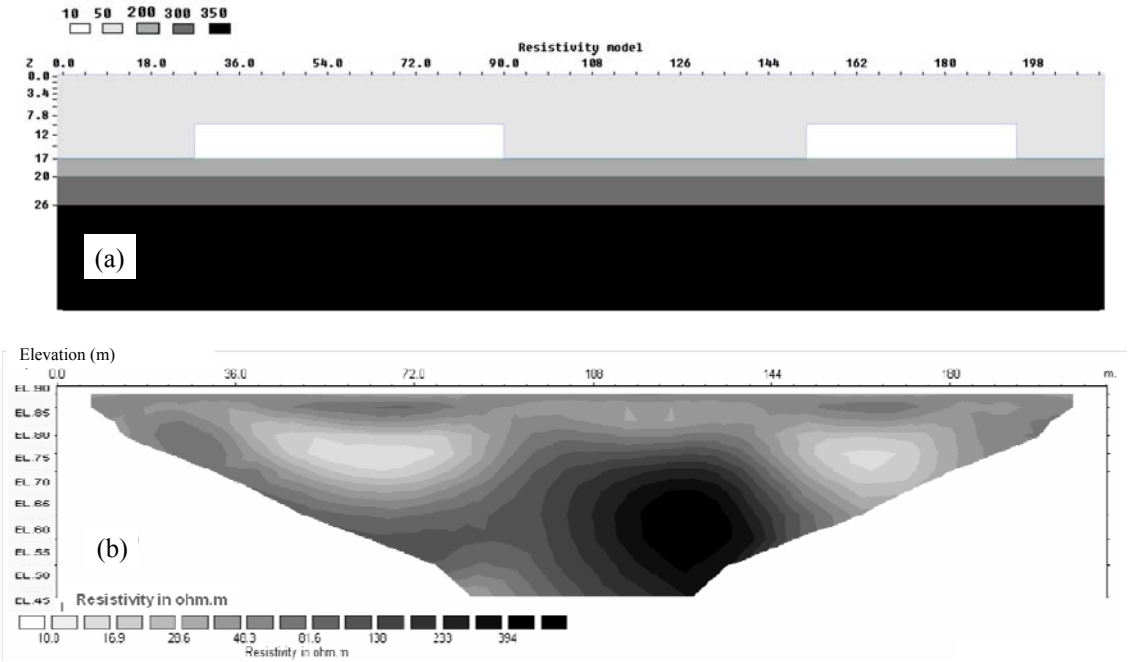
The earth dam is a man-made structure. It is possible to construct a resistivity model based on the inverted resistivity cross-section and educated guess. A simplified resistivity model for Line B before topography correction is shown in Fig. 10(a). Due to water infiltration, the top layer is relatively low in resistivity underlain by three gradually higher resistivity layers. Two low resistivity zones are included near the bottom of the top layer to simulate the wetted areas. A forward model was performed using Res2Dmod (Geotomo Software 2002) to generate synthetic data

Fig. 10 (a) A simplified resistivity model for Line B; (b) inverted resistivity cross-section using synthetic data of the simplified model

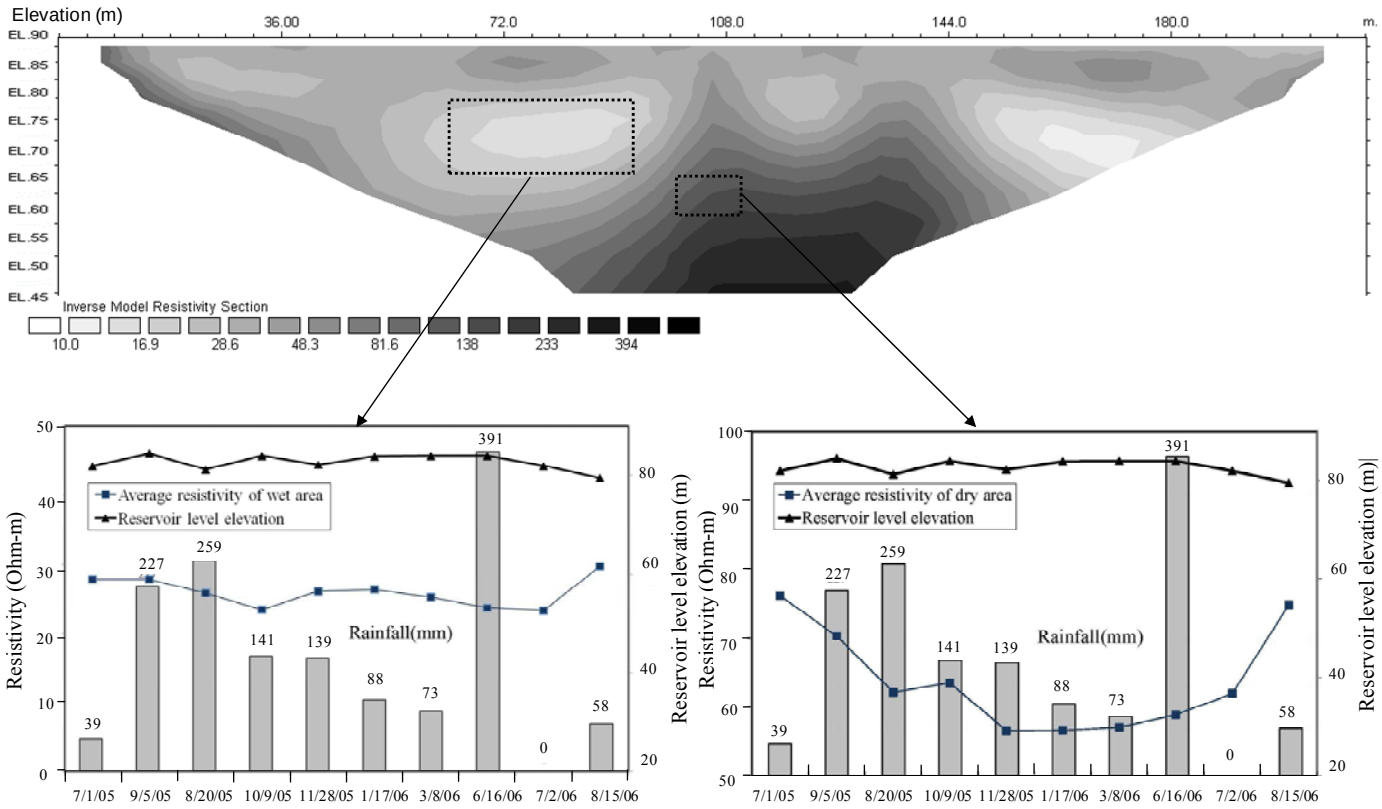
Fig. 11 Time-lapse resistivity in relation with reservoir water level and precipitation in the low resistivity (left) and high resistivity (right) zone

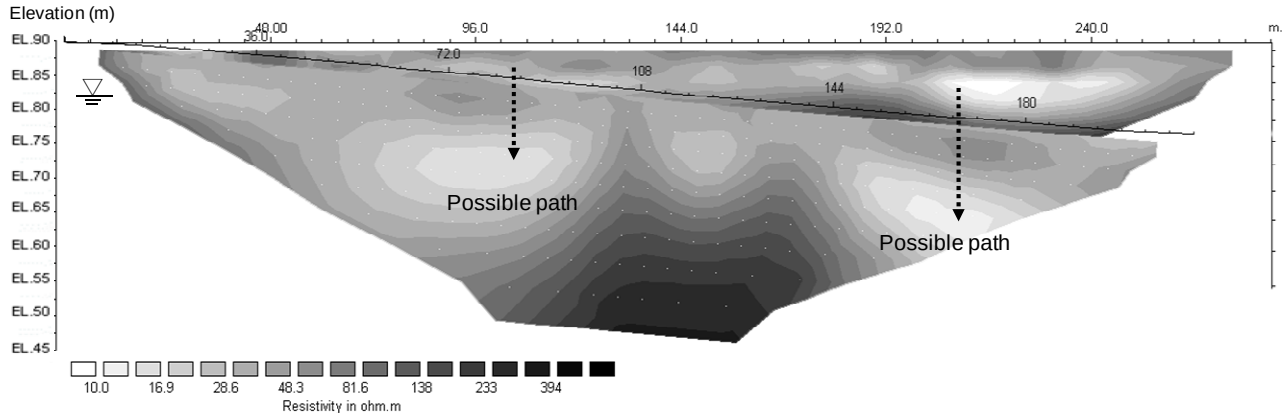
The two low resistivity zones in Line B cross-section appear to spatially correlate with those two in Line A cross-section. Because the core inclines towards the upstream, the cross-section of Line A actually projects into the upper part of the shell. Line B extends from the top of the dam at the right abutment to the lower part of the shell at the left abutment. Possible paths for the anomalous seepage are depicted in Fig. 12 by combining the two cross-sections. These two possible pathways happen to correspond to the abnormal leakage spots 3 and 4 shown in Fig. 4, and further downstream to spots 1 and 2. The geophysical testing helps to reveal the underground pathways of the anomalous seepage. But interpretation for the possible mechanism requires integrating the geophysical results with geotechnical data. The dam was instrumented with several open standpipe piezometers. The dam cross-section near the abnormal leakage spots 2 and 4 is presented in Fig. 13 along with the results from ERT and piezometers. The phreatic line of the dam seepage is unexpectedly above the drainage layer at the lower part of the downstream shell as revealed by the hydraulic heads from Piezometer Q3 and Q4. This anomaly and the associated explanation require a separate investigation. The low resistivity zones and the possible pathways of the anomalous leakage at the downstream face are well above the phreatic line. This indicates that the abnormal leakage is not directly related to the steady-state seepage of the reservoir. According to the leakage monitoring, the amount of the abnormal leakage depend greatly on the precipitation. A possible explanation is that the perched low resistivity (wet) zones are due to rainfall infiltration trapped by some impermeable layers in the shell. The perched water finds its way out at the spot 4 and further downstream to the spot 2 with significantly less amount. The abnormal seepages found at the spot 3 and spot 1 seem to be in a similar situation.

Fig. 12 Combined representation of results from Line A and Line B

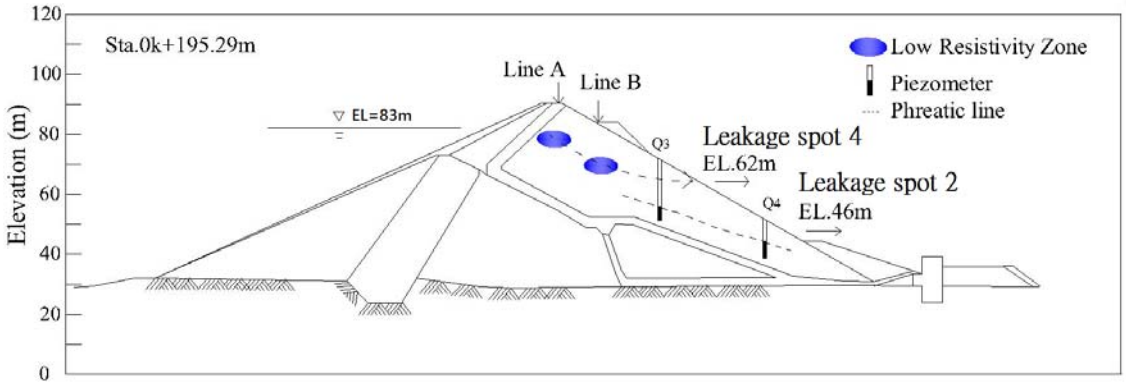
Fig. 13 The low resistivity zones from ERT and hydraulic heads from piezomters on the dam cross-section near abnormal leakage spots 2 (EL. 46 m) and 4 (EL. 62 m)
