# STABILITY ANALYSIS OF EARTH DAM SLOPES SUBJECTED TO EARTHQUAKE USING ERT RESULTS INTERPRETATION

Eko Andi Suryo

Lecturer / Department of Civil Engineering, Faculty of Engineering /  
University of Brawijaya

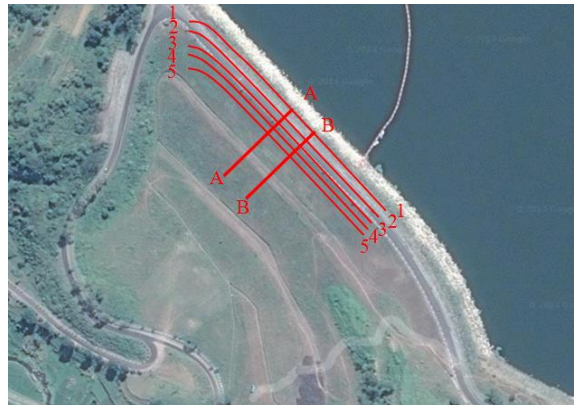
**Fig. 2.** ERT profile lines plotting on the body of the earth dam

First five ERT surveys were carried out along the dam crest and downstream site to investigate the zone of low value of soil resistivity as the weak site. Then, two profile lines were conducted across the weak section of the dam body. Plotting of the profiles lines is presented in **Fig.2**. The results of ERT using Wenner configuration survey are shown in **Fig.3**.
